Open
System

OPEN SYSTEM PRODUCTS NEWSLETTER

VOLUME IV - 1992

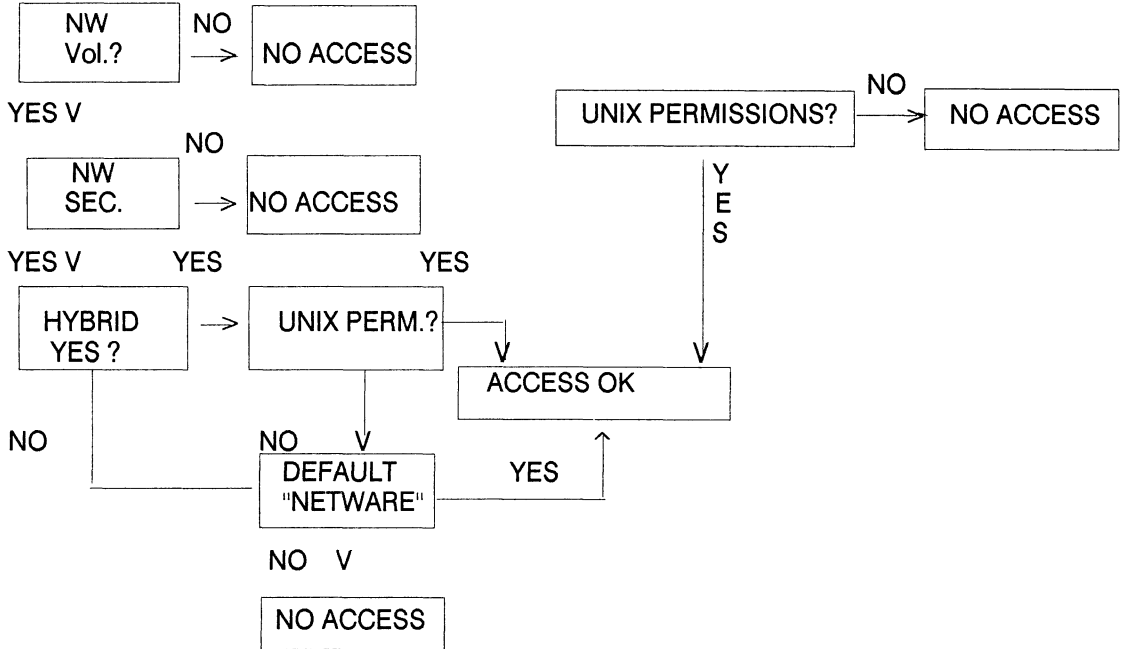
NETWARE USER:

UNIX USER:

File access is one thing, but file sharing is another. To allow both NetWare users and Unix users to share files, a locking mechanism should be used. By default, NetWare does its own file and record locking. This means that Unix users still have access to files that are locked by PC applications. You can set up NetWare for AViiON to use "native locks", meaning that when NetWare-ready applications lock files, these files will also be locked in DG/UX to prevent DG/UX applications from accessing the file. These locks are DG/UX advisory locks by default, and its up to the Unix application to respect the file lock, and take the proper action. DG/UX mandatory locks can be used, but you must alter the file_mask variable in the NWConfig file. See the man page for "chmod" for more information on this.
